**Special Report 81-3**

AN INVESTIGATION OF THE SNOW ADJACENT TO DYE-2, GREENLAND

H.T. Ueda, M.A. Goff and K.G. Nielsen

UNITED STATES ARMY CORPS OF ENGINEERS COLD REGIONS RESEARCH AND ENGINEERING LABORATORY HANOVER, NEW HAMPSHIRE, U.S.A.

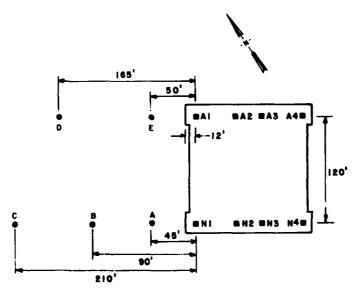
Figure 3. Sample hole locations at DYE-2.

During the period 26-29 July 1979, five holes were augered on the west side of DYE-2 using a CRREL 3-in. (76-mm) coring auger. Three holes were located 45 ft (13.7 m) 90 ft (27.4 m), and 210 ft (64 m) from the building along the "N" row column line. Two holes were located 50 ft (15.2 m) and 165 ft (50.3 m) from the building along the "n" row column line (Fig. 3). Each hole was augered to a depth of 50 ft (15.2 m), required an average of 39 runs, and took approximately 3.5 hr to complete. Two sections of construction scaffolding provided an overhead platform about 7 ft (2.1 m) high which permitted handling the auger extensions in 12- to 15-ft (4- to 5-m) lengths (Fig. 4).

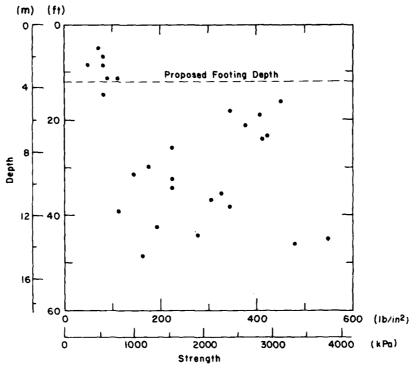
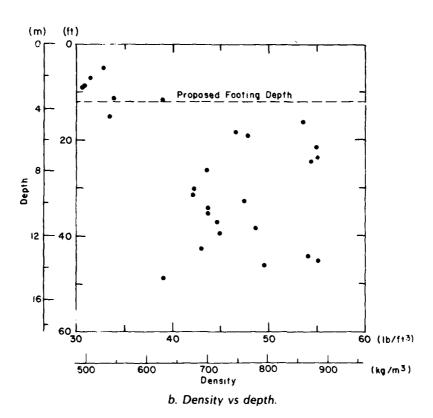
Figure C4. Borehole D, location A1 + 165, DYE-2, 1979.

Below the design footing depths proposed for a sideways move, all samples displayed a strength exceeding 61 psi (0.42 MPa) except for two samples from borehole E. Samples E8 and E13 failed at 41 psi (0.28 MPa) and 31 psi (0.21 MPa) respectively. The value of 31 psi (0.21 MPa) is the minimum measured strength of the snow which will support the footings.

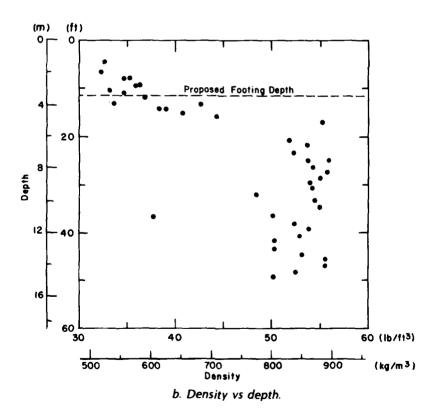
Figure C5. Borehole E, location A1 + 50, DYE-2, 1979.

Samples from borehole E, which is located 50 ft (15.2 m) from column A1, produced the highest and lowest strengths of 1065 psi (7.37 MPa) and 31 psi (0.21 MPa) respectively. Using the minimum value of strength found and following
